**NATIONAL BODY OF AIR ACCIDENT AND INCIDENT
INVESTIGATION IN CIVIL AVIATION**

DRAFT FINAL REPORT – OKIIA20190910

In 10.09.2019, time 10:00:02, at Tirana International Airport aircraft of Guardia di Finanza (GDF) type P66T with callsign I2266 passed behind B737 operated by Air Horizont (AH) with registration 9H-GTC, while AH was performing engine test. OKIIA investigators were notified at 12:28.

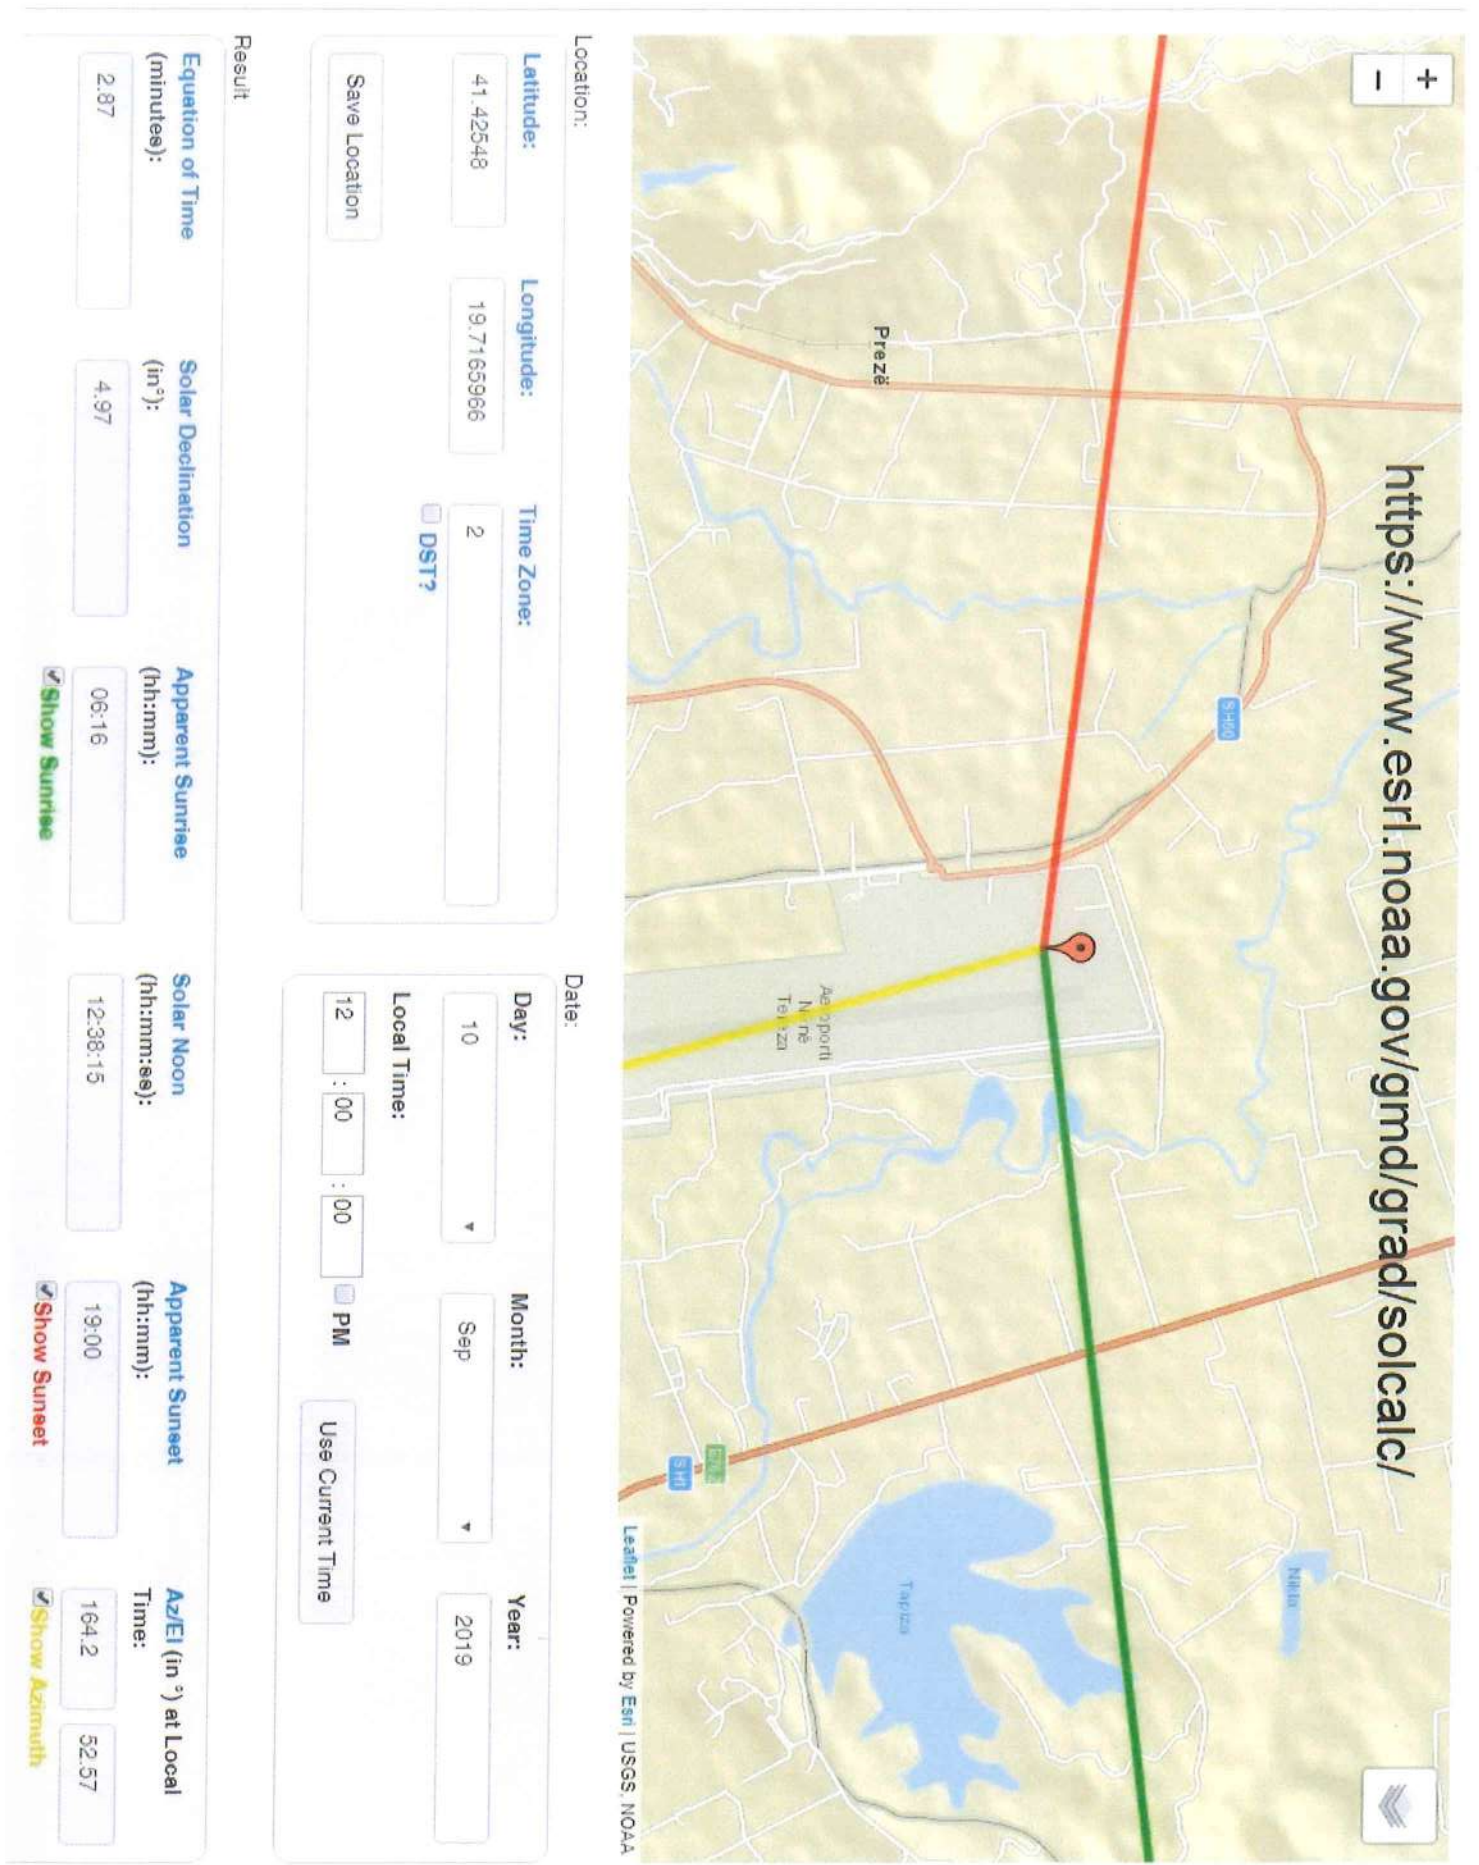
Pic. 2.5

- 2.5 Meteorological Information** - CAVOK; weather has no contribution in the incident (see pic.2.5)
- 2.6 Communications** – Albcontrol provided transcript of communications (see transcript).

OKIIA is of the opinion that standard procedures were not followed; heavy radio communication contributed to occurrence; having sun (see attachment) in front during taxiway (GDF) may have also contributed to this occurrence.
